Analysis of 5 Floor Brick Masonry Building, Type 77/5

Petraq Koka

Lecturer at European University of Tirana

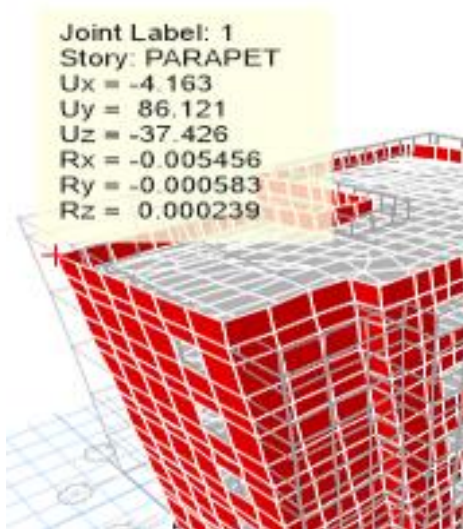
1- Displacement (*with gray lines the deformed shape of the building is presented*)

Fig. 3 – Displacements for the original building

Maximum displacement of the building, in the linear phase is $U_y = 8.61\text{cm} > 7.1\text{ cm}$, for the combination:

$$\text{ELY: } D + 0.3L + 0.3\text{EQLX} + \text{EQLY}$$

While in the nonlinear phase this displacement is:

$$8.61 * q = 8.61 * 1.5 = 12.91\text{ cm} \gg 7.1\text{ cm}$$

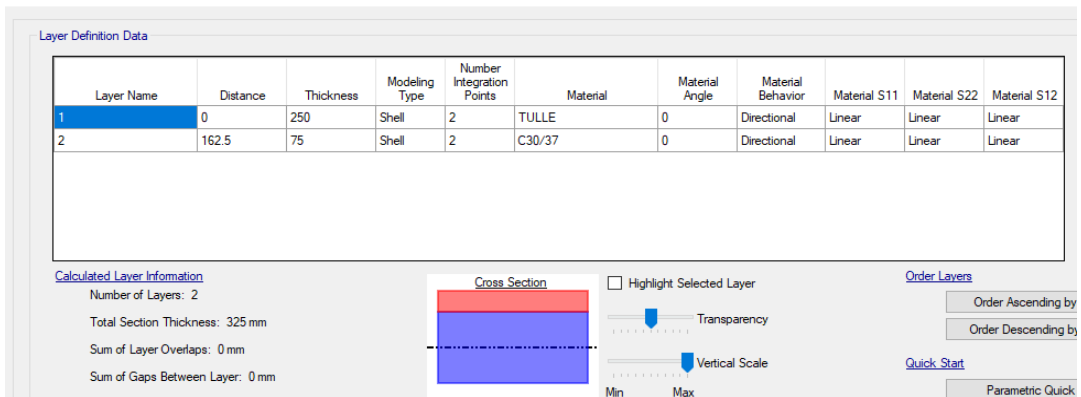
ET Wall Property Layer Definition Data - MURI25

Fig. 4 – Wall layered data C30/37

Based on the layered option provided by Etabs, it was assumed that we add outside masonry a 75 mm thick concrete cladding. A version with 2 "integration points" has been accepted.

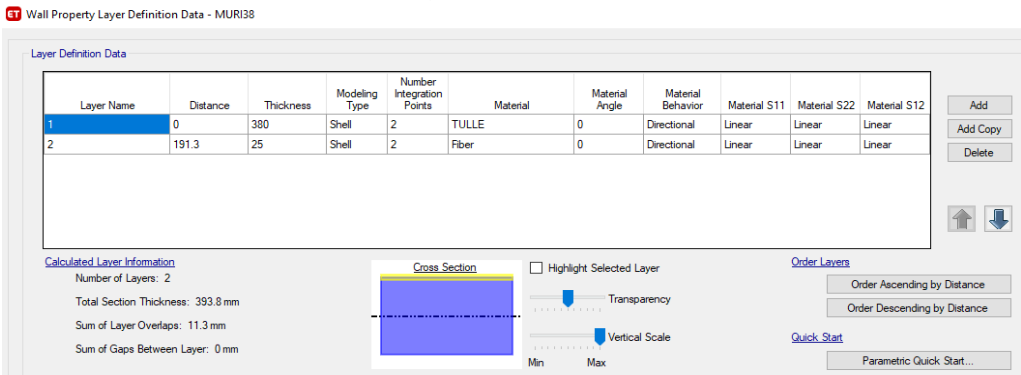
Fig. 7 - The fiber-glass layer on the outer wall of the masonry, for a wall of 25 cm

The period for this case is 0.646 sec, the Uy displacement meet an insignificant decrease, it becomes 97.92mm

Longitudinal module E_L	D3039	53-59
Transverse module E_T	D3039	16-20
Axial shearing module G_{LT}	D3518	6 -9
Poisson's coefficient μ_{LT}	D3039	0.26-0.28
Resistance		MPa
Longitudinal traction $F_{T_L}^T$	D3039	1590-2000
Longitudinal pressure $F_{C_C}^C$	D3410	690-1240
Transverse traction $F_{T_T}^T$	D3039	41-82
Transverse pressure $F_{CH_T}^C$	D3410	110-200

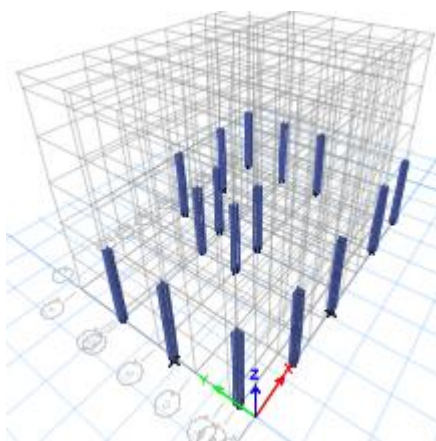
Fig 8- Columns in 2 floors

Attempt 4: *COLUMNS only on the first 2 floors*

In this attempt, finally, the Periods and Displacements have met the intended Target

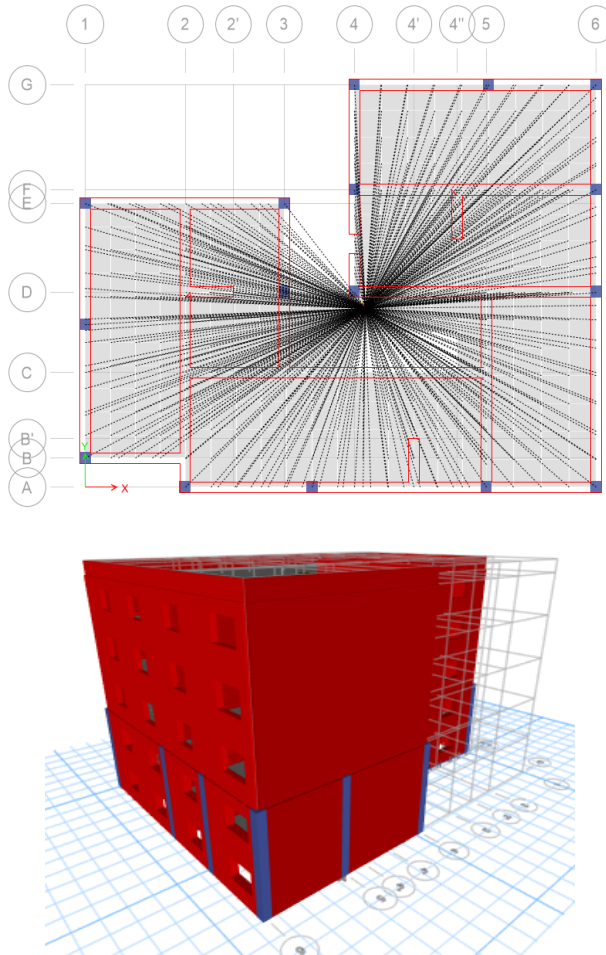
Fig.10 - The column position, in plan and in 3D.
